LEARNING FROM ACCIDENTS

Captain Henk Hensen FNI

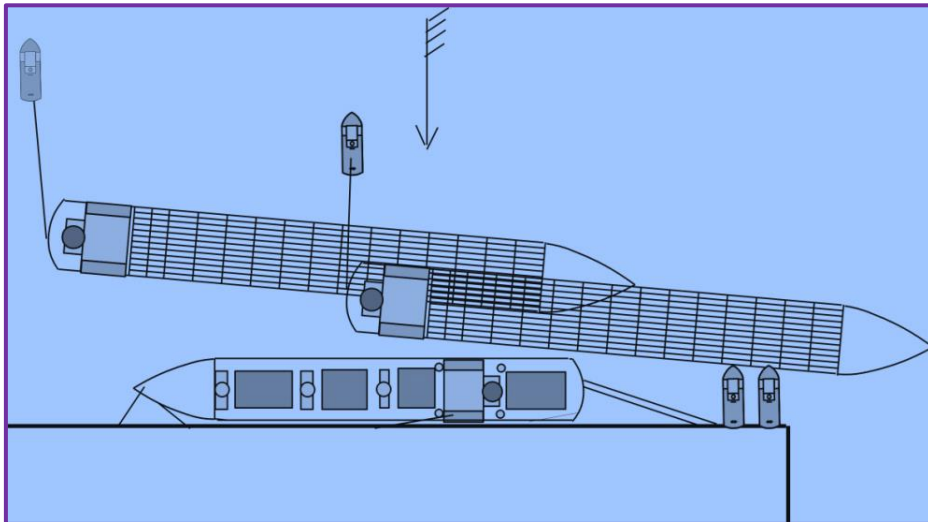
Figure 1. Accident with CMA CGM DeBussy

As an example, an accident to the container ship *CMA CGM DeBussy* will be used. The accident happened in the port of Constanta in March 2010. As a result of strong winds the ship drifted against the Turkish freighter *Haci Fatima Sari* and one of the assisting tugs was crushed between the container ship and the berth.

It is assumed the pilot *CMA CGM DeBussy* did not do that. He took the risk, or perhaps he had no idea there was any risk involved. The result was that the ship collided with a berthed ship and one of the tugs got crushed between ship and berth. Luckily, there were no casualties.

If the pilot had calculated the total required bollard pull, he could have seen that the three tugs available did not have sufficient bollard pull to keep the ship under control. The container ship probably had a working bow thruster, but as soon as a ship gathers headway the effect of the bow thruster decreases fast. This should have been taken into account. Because the pilot did not assess the required bollard pull, ships and tugs were put in danger.

If the forward tugs had been pulling instead of pushing, the accident would not have had such serious consequences. The tugs could keep pulling up to the last moment, no tug would have been damaged and the damage to the ship alongside would have been less. In such critical cases it is better that the tugs are pulling as the stern tug did. In several other cases tugs have been crushed between ship and berth, and all these accidents could have been avoided.

- Pilots should be trained to calculate the required bollard in case of strong winds. Some ports already do this, but many do not. All simulator training courses train pilots in how to handle a ship safely, but at least the simple calculation method outlined above should be included in the training.
- It is strongly recommended that in ports where pilots have to handle large container ships, gas carriers and car carriers, they are equipped with a simple tool that can calculate the required bollard pull.
- In case of emergency, tug masters should be trained to take the initiative to prevent the tug from becoming crushed (see note below).

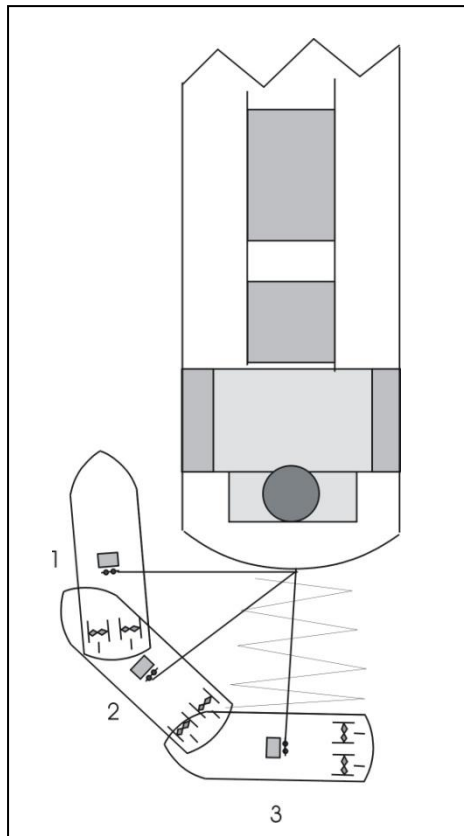
Figure 4a

Three other accidents. Lack of knowledge of tug capabilities has caused serious accidents, sometimes with fatal consequences.

An example: A pilot brought a bulk carrier into port. He asked for one ASD-tug as stern tug, but was told he would get the brand new conventional tug. Not aware of the limitations of the conventional tug, he instructed it to go from position 1 to a position astern of the vessel to assist in braking the ship's speed. The speed of the vessel at that time was at least about 5 knots and the engine was still on Dead Slow Ahead. The result was that the tug started to capsize in position 2 and was pulled by the ship, while capsized in position 3, for several minutes. The pilot was not aware this was happening. When approaching the berth, the ship's engine was stopped, so the force on the towline decreased and the tug came upright again. There were no fatalities.

It must be said that the tug master in this case, although very experienced, had no experience of the particular manoeuvre he wanted to carry out. Such manoeuvres should only be carried out at speeds below 3 knots and with the ship's propeller stopped! Accidents such as this one have resulted several times in serious consequences for the tug crew. The quick release system should have been activated, but does not always work in such circumstances. Sometimes the tug and crew are only saved by a breaking towline.

- The importance of experience with a specific tug type and knowledge of the capabilities and limitations of the assisting tugs, which applies to tug masters as well as to pilots.
- Most situations can be taught on a simulator, although in the case of bow-to-bow operations the tug model should carefully reproduce the capabilities of the ASD-tug when operating bow-to-bow. It should be recognized that there is a large difference between various ASD-tug designs.
- Careless thoughtless attitudes can be modified after a simulator training course.
- The importance of proper safety measures.

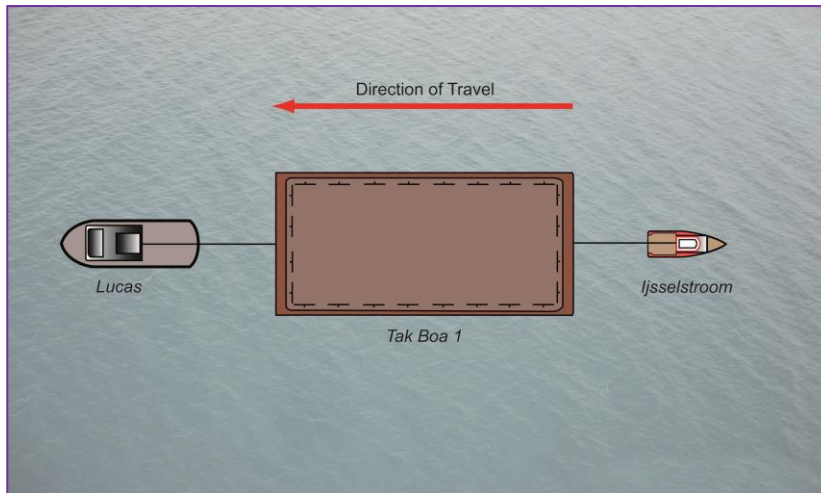
Figure 4b
Courtesy: MAIB

A comparable accident took place recently with the twin-screw tug *IJsselstroom* in the Port of Peterhead on 14 June 2009 (MAIB report of 8 April 2010; ref. 2). Please, see figure 4b. The tug was a steering tug, with engines turning ahead to keep the tug in line with the tow. The risk with such a manoeuvre is that if with increasing speed (say up to 3 – 4 knots) the tug veers away, it will become impossible to bring it back in line with the tow. The towline under high tension will then come near right angles to the tug, which will result in capsizing. This is what happened.

The tug had no gob rope system, which COULD have prevented capsizing, IF speed through the water would have been less than about 3 knots, but bearing in mind the small heeling angle at which tug's deck edge submerges, this was by no means guaranteed. The rather old system of a gob rope winch, which can pull the towline down and shift the towing point to the after end of the tug, would have prevented the tug veering off and consequently capsizing. The tug was not equipped with such a system, which is compulsory on, for instance, German conventional tugs.

A radial system could also have prevented this accident, but the tug did not have such a system. The new Dynamic Oval Towing System (DOTS) which is fitted on the small tug *Ugie Runner*, or the Carousel System, could have prevented capsizing as well. These systems are

The major factor in these accidents is a failure to appreciate the limitations of the tug, by both the tug master and the pilot. And such accidents still happen much too often!

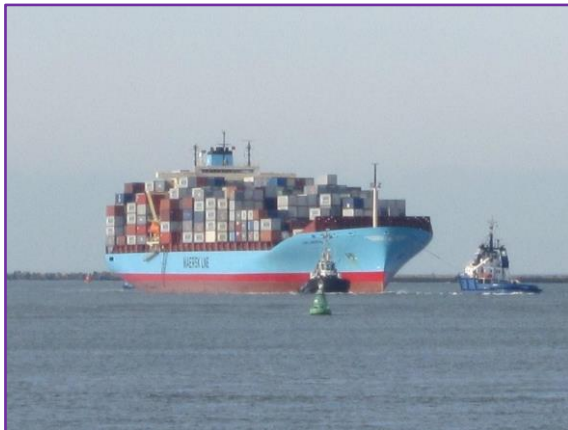
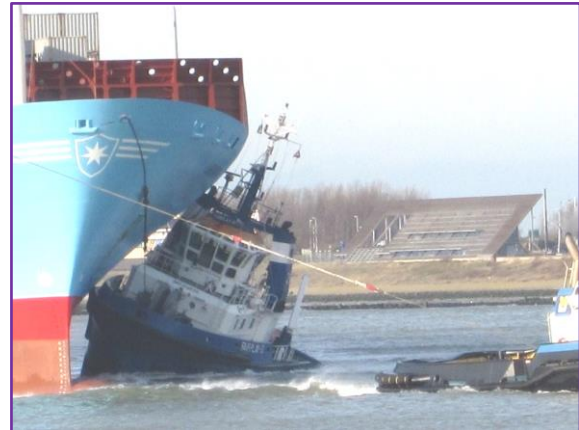
Figure 5 and 6 show another kind of serious accident. Such an accident do happen more than once with ASD-tugs operating bow-to-bow and are caused by a too high ship's speed and/or insufficient experience of the tug master with the specific ASD-tug. If ship's speed is the cause, then the pilot plays a role in it as well.

Operating bow-to-bow with an ASD-tug is a rather risky operation and needs a lot of experience and a thorough knowledge of the tug's capabilities and limitations particularly with respect to speed [ref. 3]. The tug shown swung around and came under the bow of the attended ship.

The accidents shown also demonstrate the importance of proper safety measures on board tugs. During tug operations doors, deck openings, etc. should be closed to prevent flooding of the tug with large angles of heel.

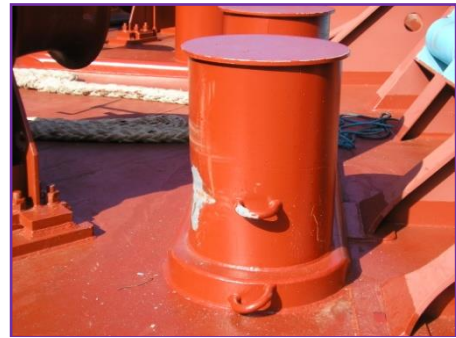
Figuur 8

*Courtesy: KOTUG, Rotterdam
Top eye on bollard will damage the towline*
