International **Tug & OSV**

Safe tug operation: Who takes the lead?

Capt Henk Hensen FNI FITA considers, for IT&O, tug operations near a ship's bow – the risks, the tragedies, what we can learn and what we should be doing now to prevent further catastrophes.

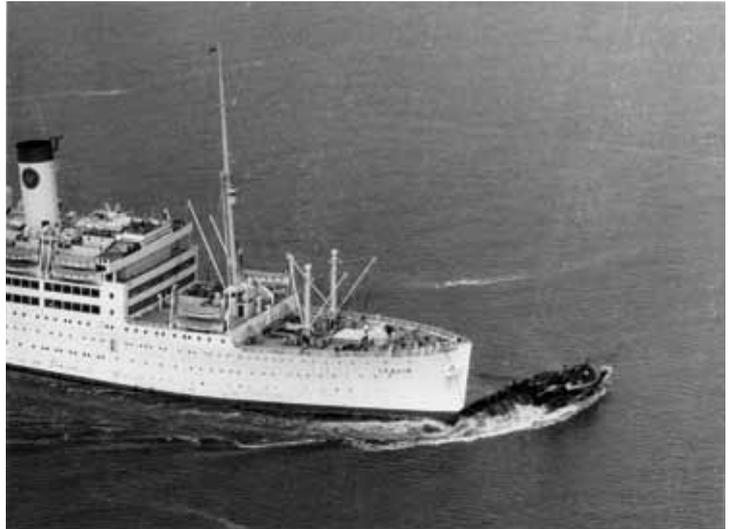
Tug operations near the bow of a ship having headway are very risky. The higher the ship's speed, the larger the risks. This is nothing new. The accident to the tug *Fairplay 1*, which came under the bow and was run down by the passenger ship *Italia* in Cuxhaven Roadstead, Germany, on 6th September 1954, is a tragic example of a tug trying to make fast at the bow of a ship having headway. This accident also illustrates the risk to human beings on board the tug. There were two casualties¹.

► *Tug Fairplay 1 capsized under the bow of the passenger ship Italia.* Copyright Jan Mordhorst, Germany.

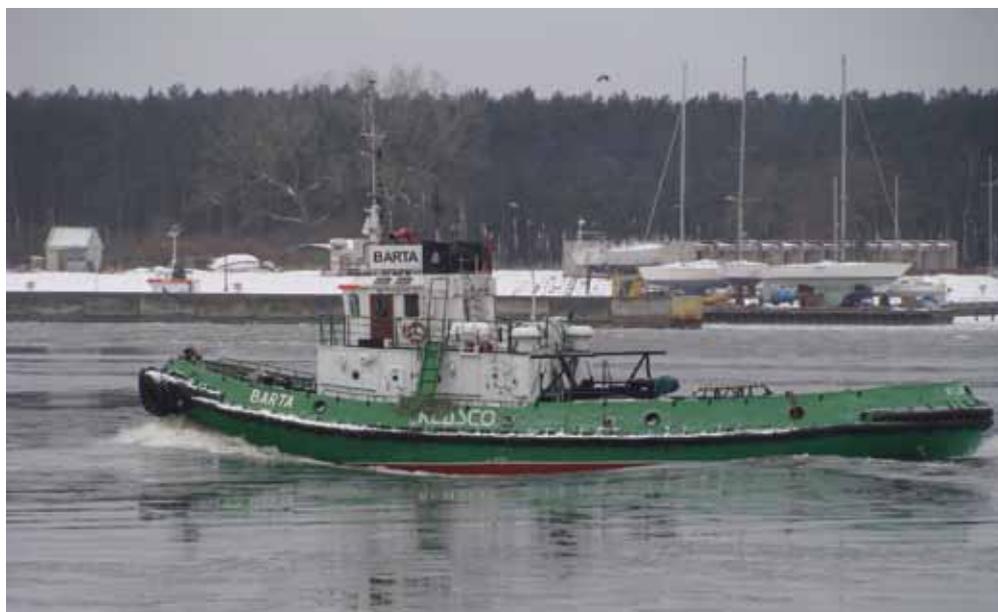
▼ *The tug Barta.* Photo: Gena Anfimov, Klaipeda.

As soon as the rope was on the tug's towing hook, the tug engine was set to full ahead and the propellers were set at an angle of 12 degrees with the tug's centre line. This angle, which improved steering performance, reduced the maximum speed from 11.5 down to 7.5 knots. With full ahead on the engine, the tug did not move ahead, and the after part of the tug came into contact with the bulb. The tug was then forced quickly to starboard, came under the bulb and capsized. The tug master and a sailor drowned. The Lithuanian Maritime Safety Administration investigated the accident and published various findings and conclusions⁹:

- The ship's speed was too high. The Safe Working Procedures applicable to towing operations in the port state that tugs are only allowed to take the towing rope from a ship when the ship's speed is at a safe minimum.
- Tug's speed margin was too small.
- Economic pressure may have played a role.
- The procedures used for passing the

- Visibility from the tug's wheelhouse was too limited to accurately position the tug.
- The tug *Barta* was not suitable to perform the manoeuvres it was expected to carry out for taking the towline.

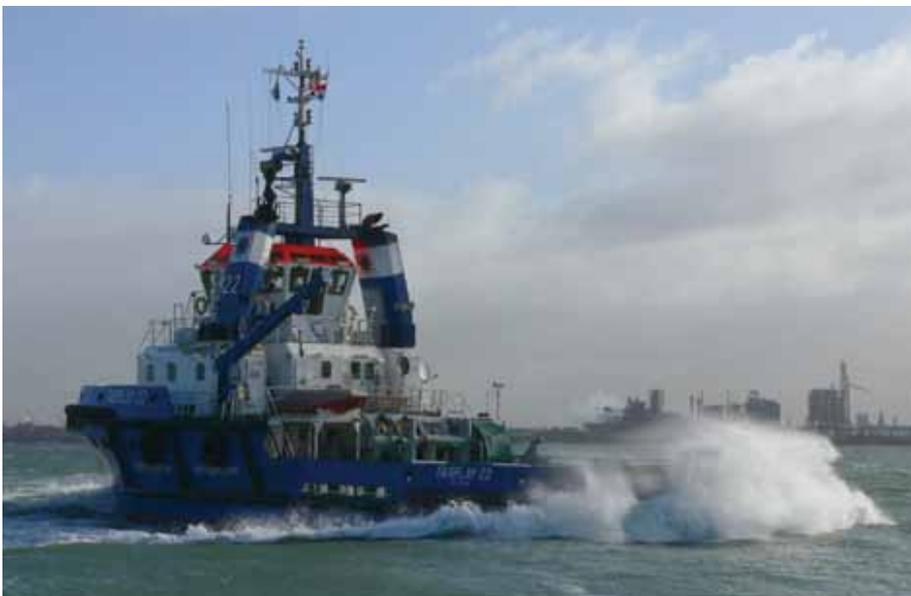
◀ Tug *Fairplay 22*.

Fairplay 22 increased speed and passed the bow of the ferry. From a position to port and forward of the bow, the tug master let *Stena Britannica* approach the tug. The tug master manoeuvred his tug on the port side of the ferry with the after part of the tug abeam of the bulb to try to pick up the heaving line again. However, the attempt failed a second time. The speed of the ferry was now 7.9 knots through the water, still higher than the agreed speed, and much higher than the 6 knots recommended by the towage company. The distance between the tug and ferry decreased fast and the tug was then hit by the bulb, capsized, and inverted, with the loss of two crew members.

- After the collision, the tug master could not manoeuvre the tug free from the bow of the ferry, due to the hydrodynamic forces working on the tug and the insufficient reserve power.

- *Fairplay 22* was pushed over by the ferry and then capsized. The limited stability of the tug and the fact that the vents of the engine room and a door leading to the afterdeck were open, contributed to the rapid capsizing.

- To the towing company with respect to:
 - Identifying the risks of a tug sailing close to the bow of a sea-going vessel; measures to be taken to keep these risks under control, particularly attention to be paid to speed through the water to be maintained,

stability and tug position when making a towline connection; implementing the safety management system; monitoring of operational procedures, including speed during tug assistance, and the closing of watertight and weathertight openings during operations (see also¹⁰).

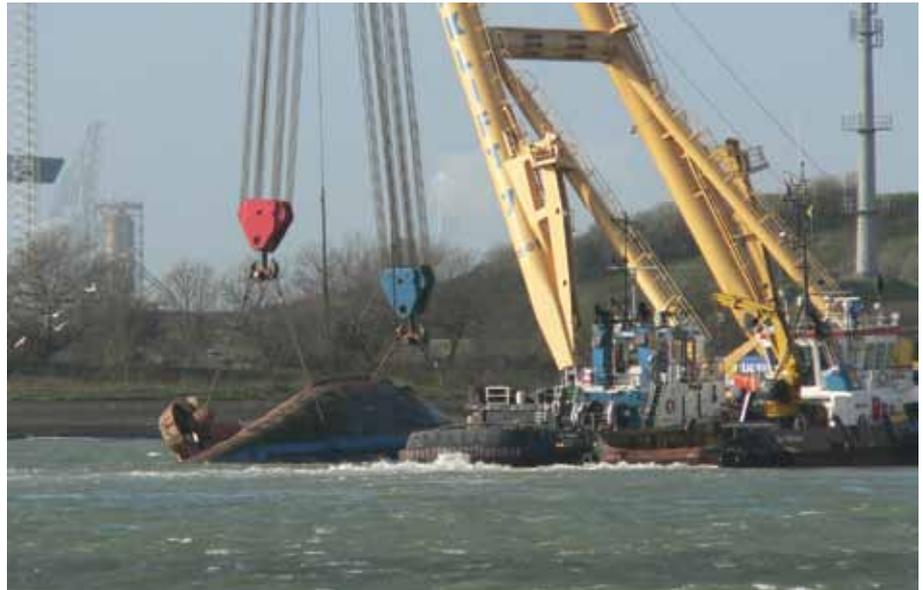
▲ *Lifting of the capsized tug Fairplay 22.*
